From:	Dy. General Manager - Tech.	For the Attention of	Mr S MAHALINGAM Dy GM-PROJECTS
Ref.No	BAS / K / Engg / 5064/2000	Company:	BHEL-PSSR, CHENNAI
Date:	28.11.2000	Fax No:	044 - 4323757
Ref:	Your Fax message ref:		
Subject: 1 X 16 MW STG

Sub : 1x16 MW Bannari Amman Sugars Ltd.
Load limitation experienced

Sub: Status of desalting of 16 MW Turbine - reg.

**MOM held between BHEL and Bannari Amman Sugars Ltd. on 13 Feb 2001
after descaling of Turbine Blading and restart of 1 x 16 MW Steam Turbine.**

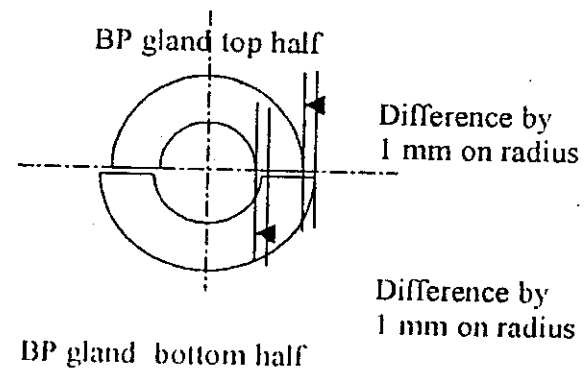
1. The Turbine was completely dismantled on 18-01-2001 (As Bolt heat equipment was not available with the customer, it was arranged by BHEL, Hyd on 20-01-2001) and all internals were cleaned by fine sand and broken rice blasting.
2. The re-assembly work is in progress. During assembly the top half of Balance Piston Gland at parting plane dia closed by 2 mm. All the internals except BP Gland are assembled and tack welded. We are not able assemble the BP Gland in distortion condition. Regarding this matter customer discussed with Sri Aravind Gupta and he suggested to send BP gland to our Hyderabad works for rectification.

3. We are held up for the final assembly. Please advise the course of action..
